## Investigation Report

Published: September 24, 2021

### SAFETY ISSUES:

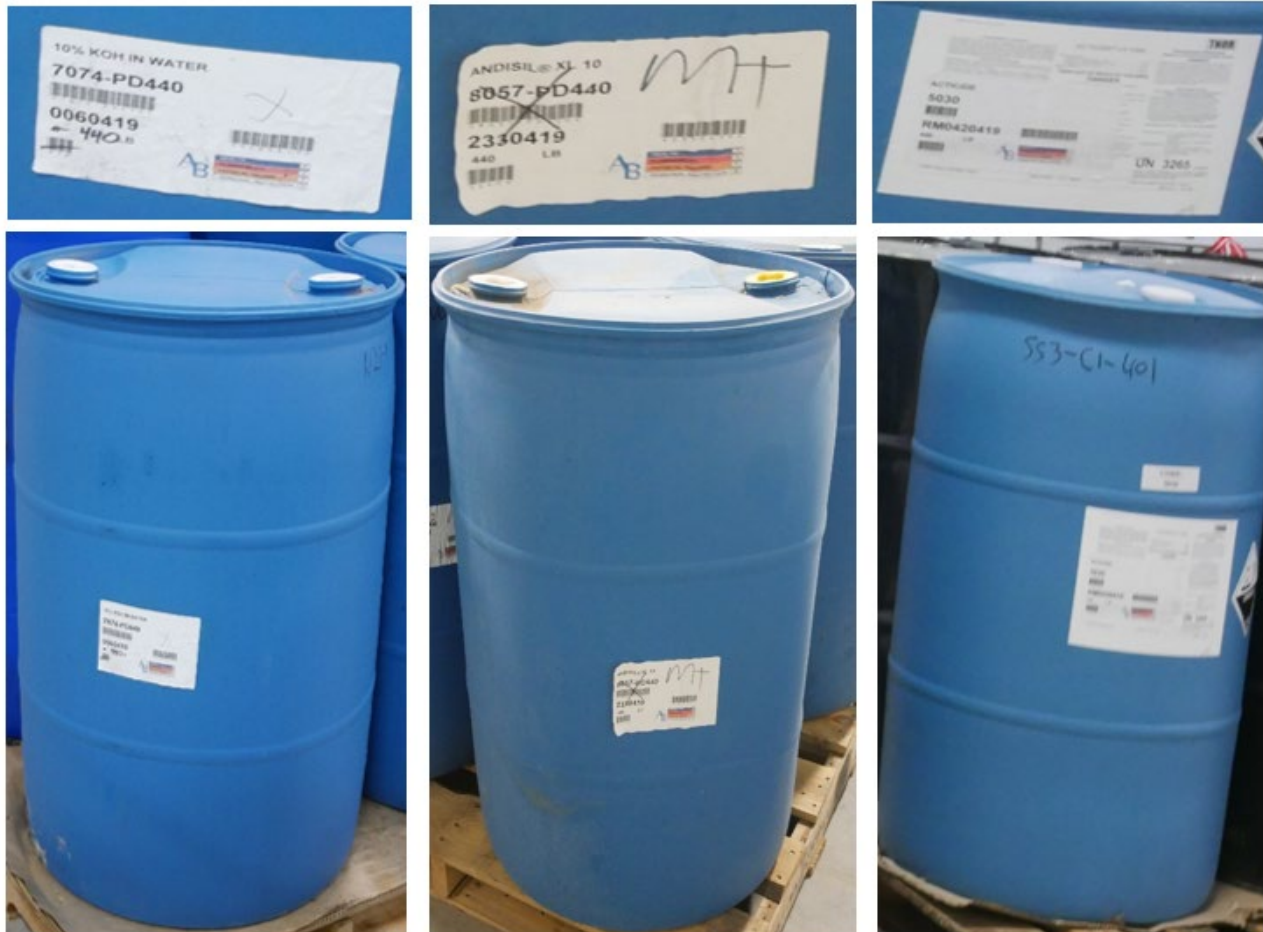
AB Specialty did not have a written procedure requiring employees to segregate the 10% KOH and XL 10 drums in the emulsions area or to remove ingredient containers from the emulsions area after use. Some chemical ingredients used in the production of EM 652, including 10% KOH and XL 10, were stored in similar 55-gallon blue plastic drums (**Figure 5**). The drums were equipped with two bung caps, often either yellow or white; the XL 10 drums typically had one white and one yellow bung cap,<sup>a</sup> and the 10% KOH drums usually had two white bung caps. Once these bung caps were removed, the drums looked nearly identical. Therefore, AB Specialty relied on its operators to confirm drum content based on the label affixed to the side of the drum, which used small text for the chemical name, as shown in **Figure 5**.

**Figure 5.** Three similar AB Specialty storage drums. From left to right: 10% KOH, XL 10, and Acticide. (Credit: CSB)

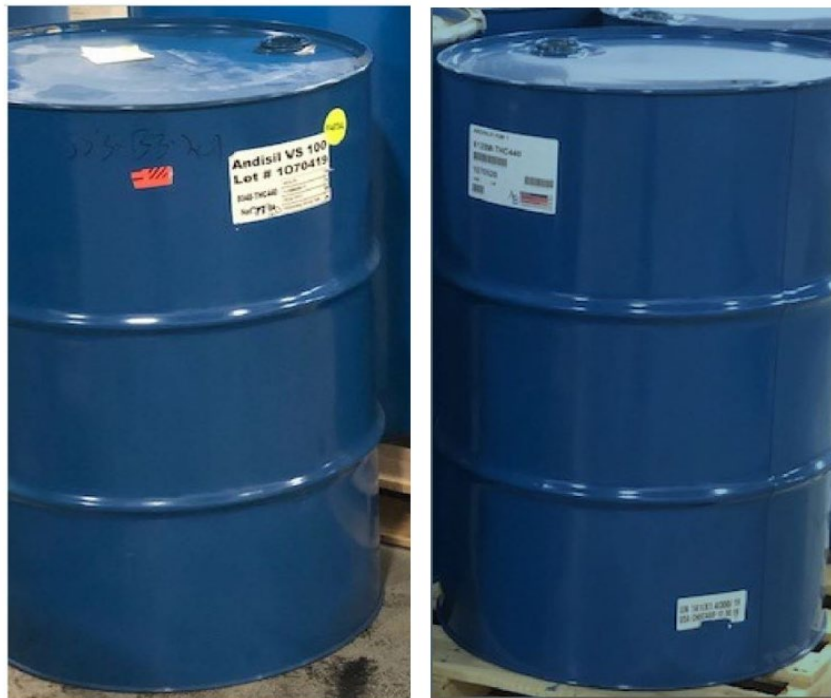
In March 2019 (about two months prior to this incident), AB Specialty experienced a near-miss event involving two chemicals stored in similar 55-gallon blue metal drums. In that event, an AB Specialty employee requested two drums of a chemical for use in a batch process. When the drums arrived in the process area, the employee looked at the affixed label on one of the drums and verified that it was the correct material. The employee then charged the material in that drum to the batch, and when that drum was empty, he began the process of charging the second drum to the batch. At that point, the employee looked at the label on the second drum and realized it was not the correct material. He immediately stopped the batch process and notified management. Aside from the printed text on the paper label, the two drums looked identical (**Figure 10**). AB Specialty logged this incident as a near miss, made the double initial practice a written procedure, and retrained all production employees. The procedure required that chemicals be verified by two employees, with those employees both initialing the batch ticket before charging chemicals to a batch.

**Figure 10.** Two chemicals in similar drums involved in previous near-miss incident. (Credit: AB Specialty)

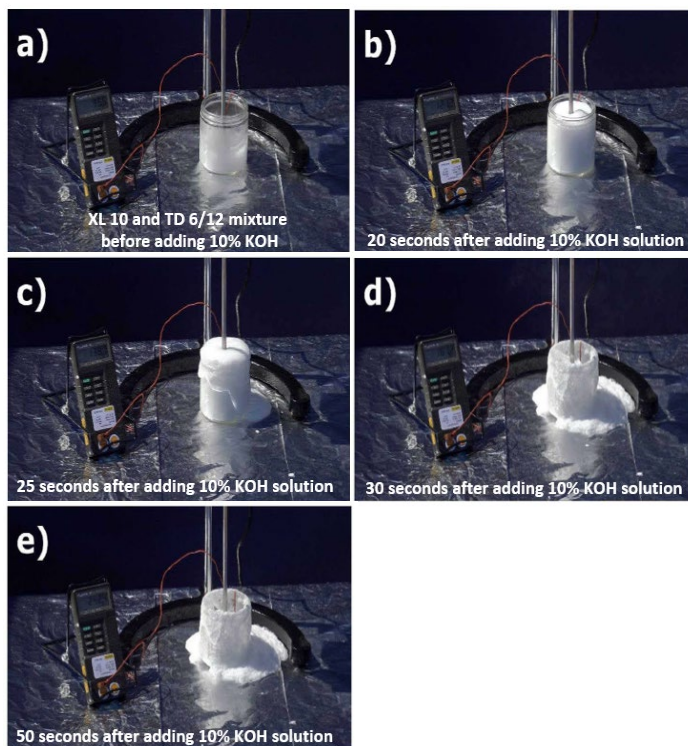
Of the multiple experiments conducted using various chemical mixtures, only one chemical combination resulted in the generation of a large quantity of flammable gas and produced foaming similar to what was observed the night of the incident. In that test, XL 10 and TD 6/12 Blend were mixed using the ratio indicated on the EM 652 batch ticket, and then 10% KOH was added to the mixture. Within about 25 seconds, the mixture turned white and foamy, formed gas, and overflowed the container (**Figure 11**). The produced gas was also tested and confirmed to be hydrogen, which was the expected gas based on the known reactivity between XL 10 and aqueous KOH.

**Figure 11.** Photographs of chemical reactivity test of XL 10, TD 6/12 Blend, and 10% KOH solution. (Credit Crane)

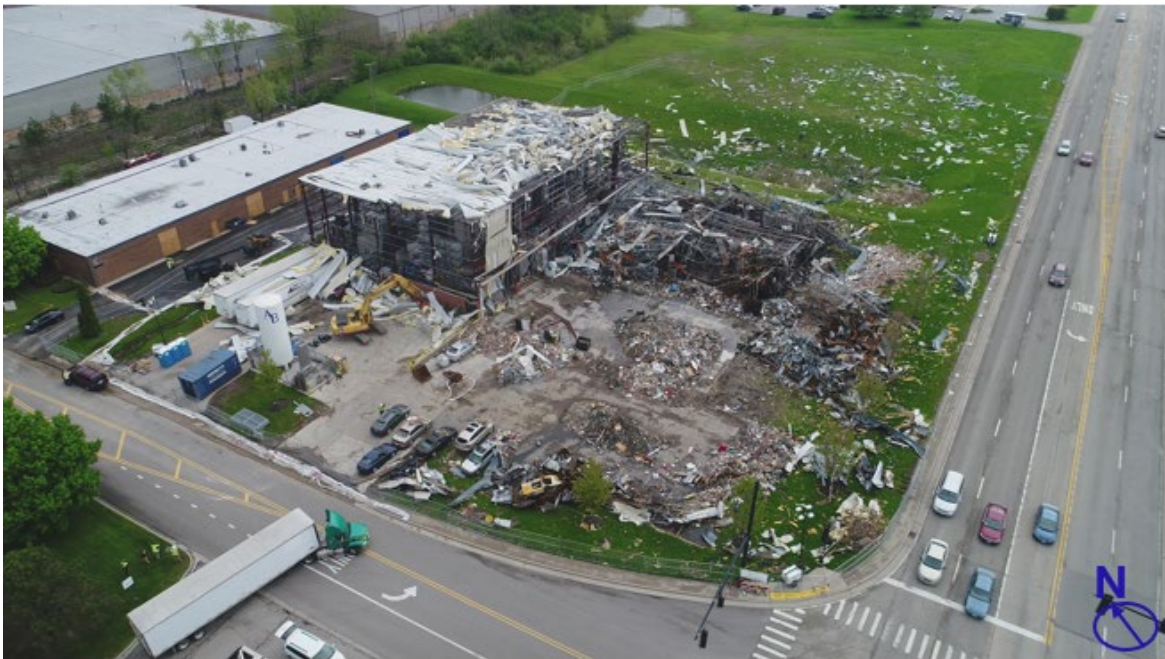
The building was destroyed by the explosion (**Figure 12**).<sup>a</sup> Debris extended for several hundred feet from the building, and nearby business properties were also damaged. Four AB Specialty employees (Operator 1, Shift Supervisor 1, a shift supervisor for a separate shift, and a QC chemist) were fatally injured by the explosion, and Operator 3 was injured.

**Figure 12.** Post-explosion photo of the AB Specialty facility. (Credit: CSB)

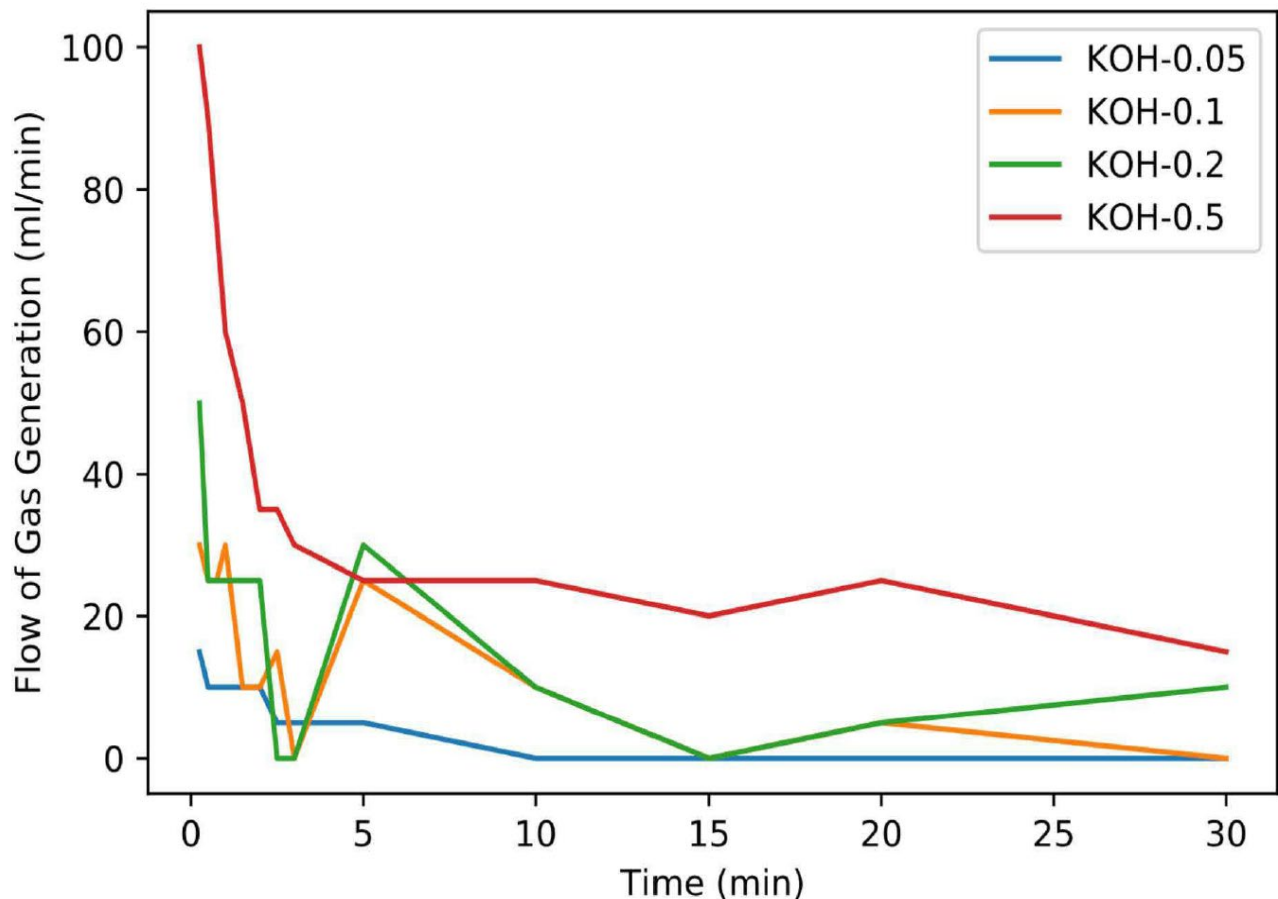
A different trend was observed when mixing XL 10 directly with 10% KOH. For all volumes of 10% KOH mixed with XL 10, gas generation rate was highest at the beginning of the experiment, shortly after the 10% KOH solution was added, and reduced as time went on, as demonstrated in **Figure C- 4**. Flow rate of gas generated by mixing different volumes of 10% KOH with XL 10 as a function of time. (Credit: Crane). The gas generation was highest when 100 ml of XL 10 was mixed with 50 ml of 10% KOH (KOH-0.5) and decreased with decreasing volumes of KOH.

**Figure C- 4.** Flow rate of gas generated by mixing different volumes of 10% KOH with XL 10 as a function of time. (Credit: Crane)

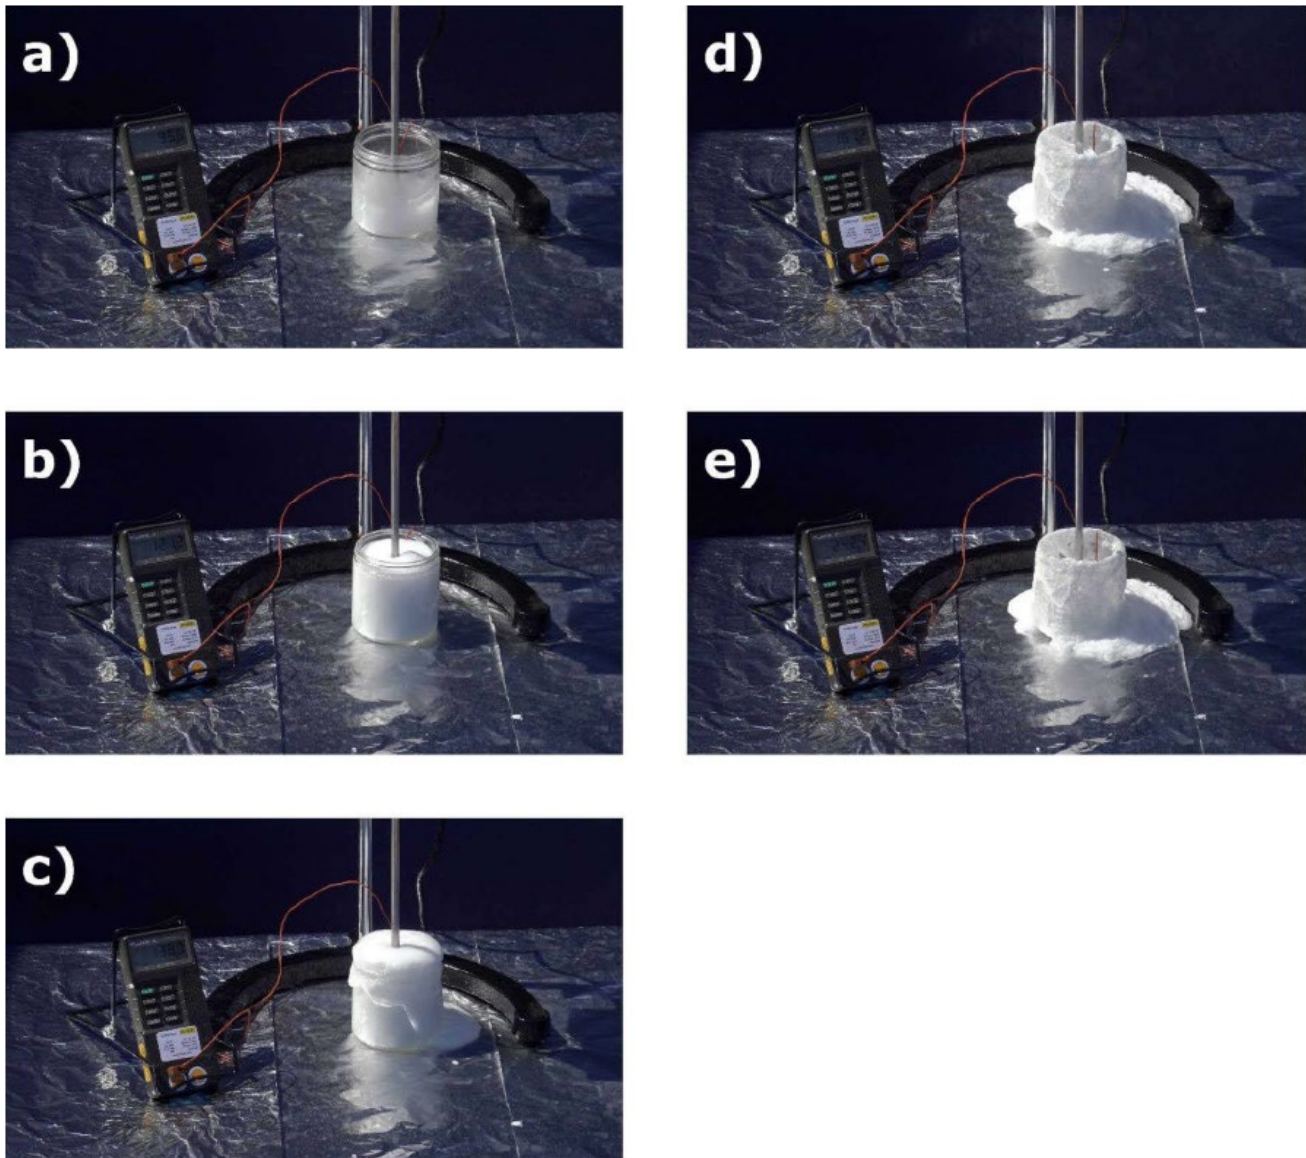
**Figure C- 5.** Photographs of o-TD-KOH test a) 5 seconds before KOH was added and b) 20 c) 25 d) 30 and e) 50 seconds after KOH was added to XL 10 and TD 6/12 Blend. (Credit: Crane)

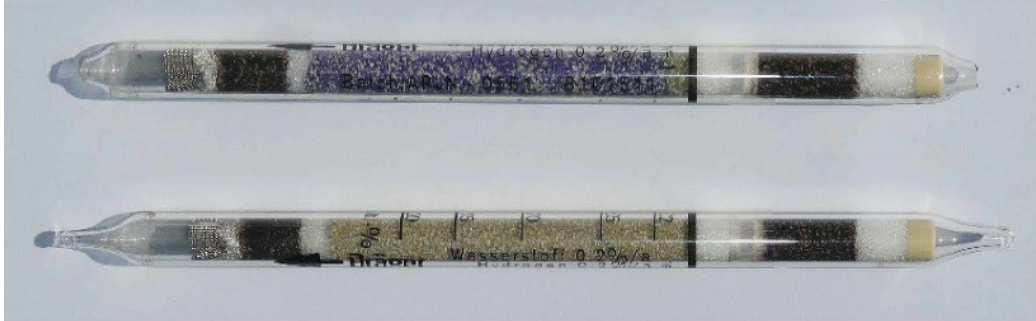
To test whether the gas being generated was hydrogen, a Drager-Tube measurement was collected during the o-TD-KOHa test. Drager-Tubes are packed with a solid substance that selectively chemically reacts with the gas that is sought to be detected. The solid material changes color according to the concentration of the gas. Tubes sensitive to hydrogen gas with a detection range of 0.2 to 2.0 volume % were used.<sup>a</sup> In the presence of hydrogen, the solid material turns from a green yellow color to a turquoise blue. The Drager-Tube used for this measurement alongside an unused one for comparison are shown in **Figure C- 6**. The turquoise color can be clearly seen along the entire length of the tube, signifying that at the point of measurement, hydrogen in air was greater than or equal to 2.0 volume %.

**Figure C- 6.** Hydrogen Dräger-Tube used to qualify hydrogen gas generation from o-TD-KOHa test (above) compared with sealed, unused Dräger-Tube (below). (Credit: Crane)

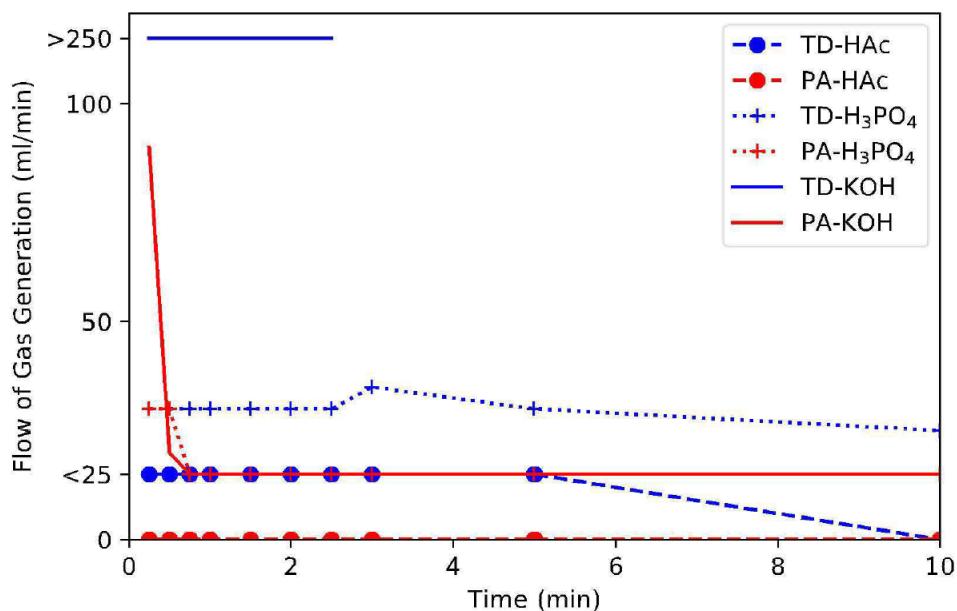
These tests were repeated in the closed setup while collecting flow rate data. The flow rate of gas generation during the first 10 minutes of each test is shown in **Figure C- 7**. Gas generation was so rapid during the TD-KOH test that it immediately exceeded the maximum capacity of the flowmeter used, was accompanied with vigorous bubbling through the oil bubbler, and an apparent heating, evidenced by what appeared to be the evaporation and re-condensation of water on the sides of the flask (**Figure C- 8**). This rapid gas and heat generation was consistent with the equivalent tests performed in the open experimental setup. The gas generation was so rapid that shortly before 3 minutes into the test, one of the joints popped off the flask.

**Figure C- 7.** Flow rate of gas generated by each test during the first 10 minutes. (Credit: Crane)

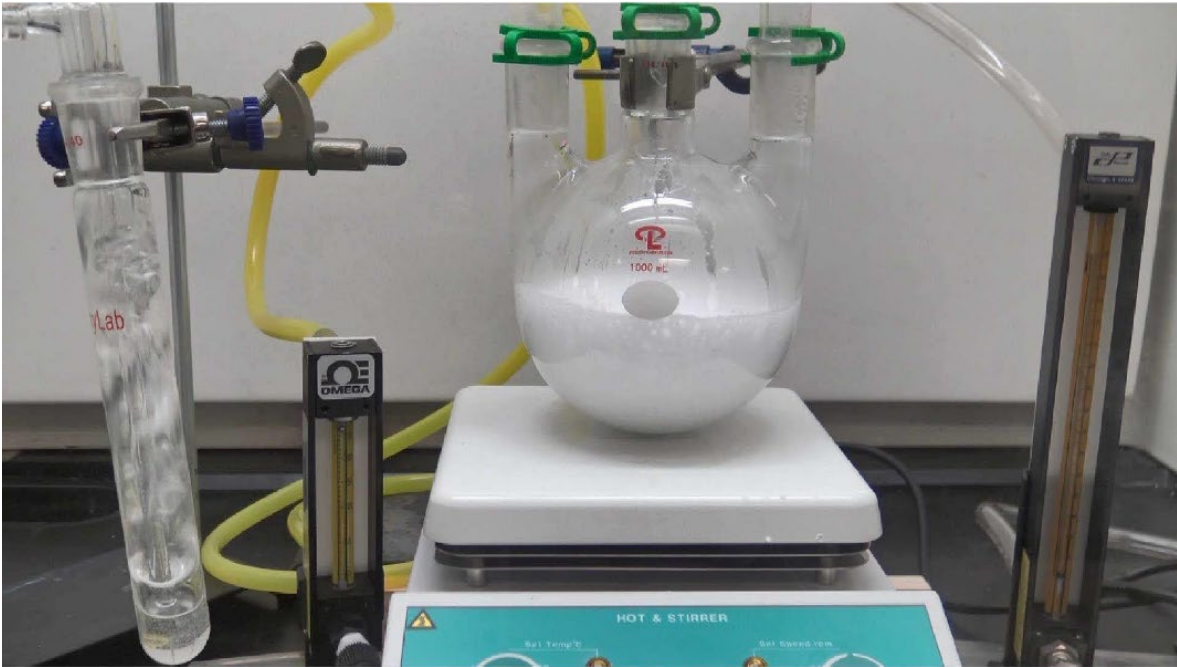
**Figure C- 8.** Photograph of TD-KOH test a few seconds before joint was blown off due to substantial gas generation. (Credit: Crane)

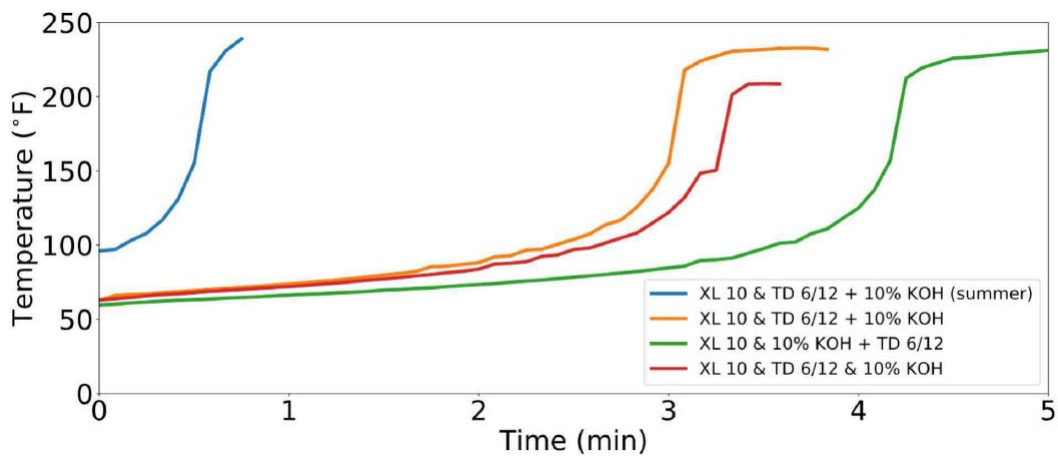
**Figure C-10.** Temperature versus time for XL 10, TD 6/12 [Blend], and 10% KOH experiments performed in an open setup. (Credit: Crane)
