INVESTIGATION REPORT

CATASTROPHIC RUPTURE OF HEAT EXCHANGER (SEVEN FATALITIES)

TESORO ANACORTES REFINERY

REPORT 2010-08-I-WA

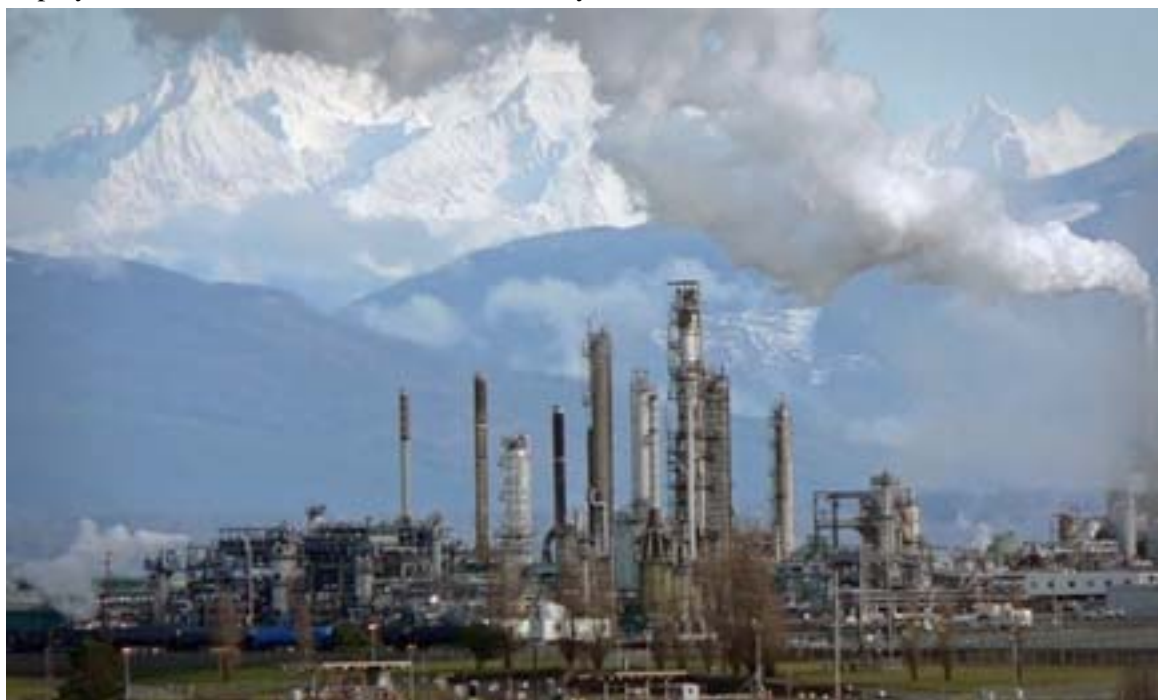
Figure 2. Tesoro Anacortes Refinery

Tesoro purchased the Anacortes refinery from Shell Oil Company in August 1998. Located approximately 70 miles north of Seattle (Figure 2 and Figure 3), the Tesoro Anacortes refinery has a total crude-oil capacity of 120,000 bpd. The refinery has been in operation since 1955.²⁹

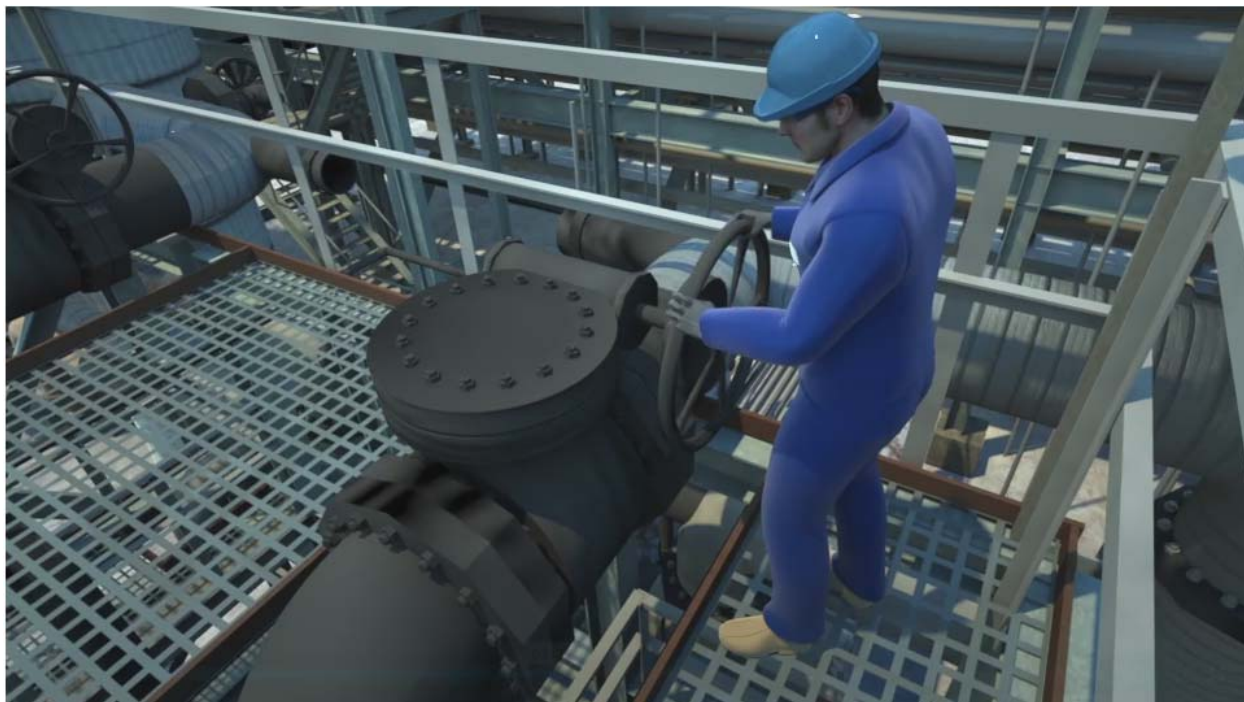
Figure 7. CSB Animation of Operator Opening Long-Winded Valve on Night of Incident. Valves on heat exchanger structure had to be opened concurrently when performing the heat exchanger bank startup

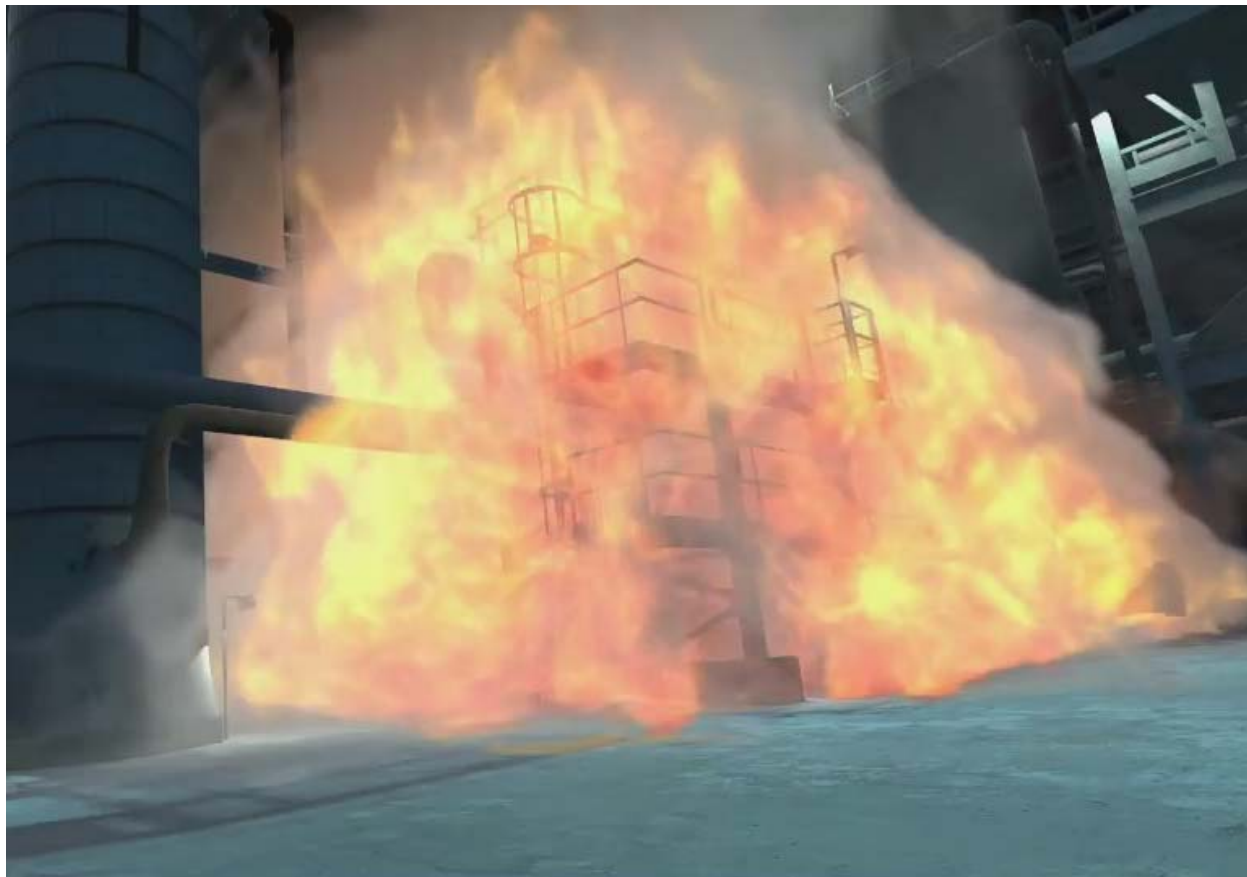
Figure 9. CSB Animation of the Fire Following the NHT Heat Exchanger Failure. The hot naphtha and hydrogen likely autoignited upon release to the atmosphere. The fire engulfed the entire heat exchanger structure.

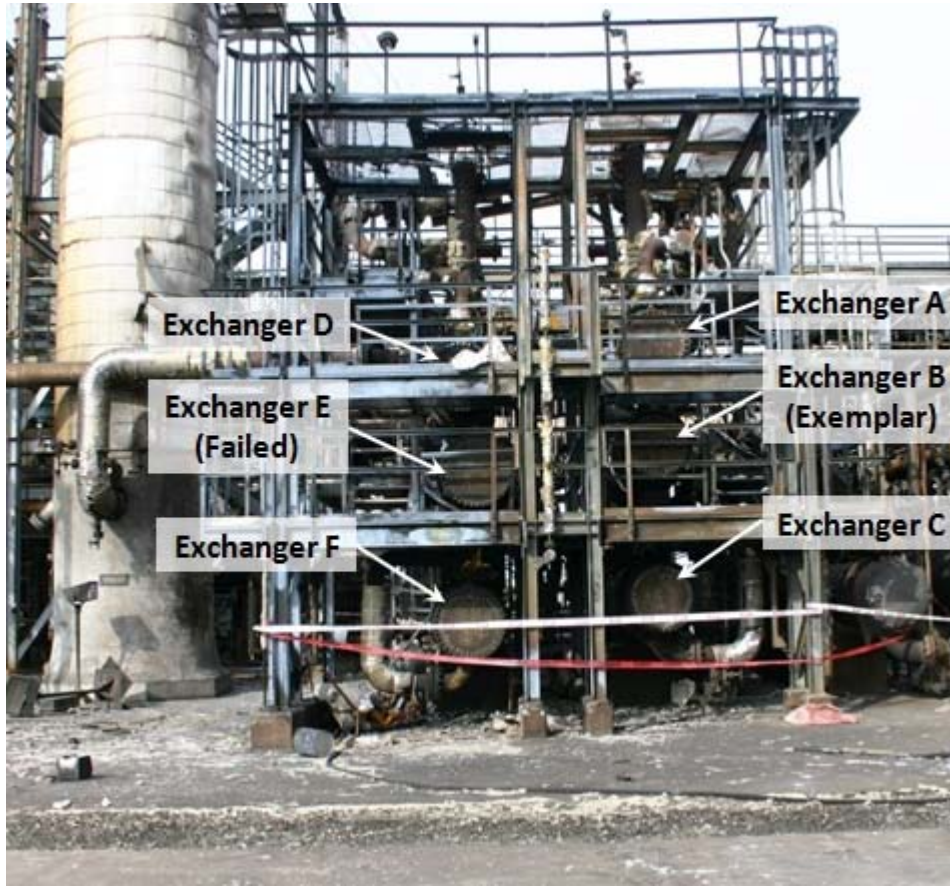
Figure 10. Six NHT Heat Exchangers in Two Banks of Three Heat Exchangers Each

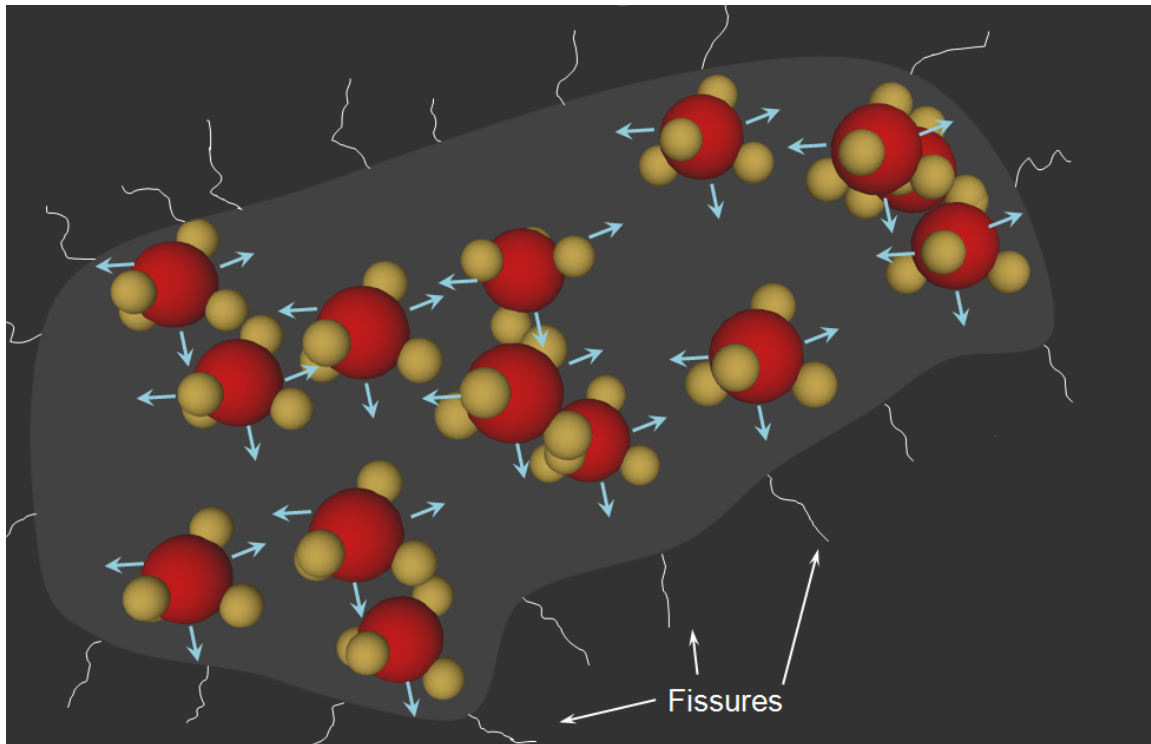
Figure 13. Methane Fissures. When methane molecules cannot diffuse out of the steel, they accumulate inside of the steel, creating high pressure that forms fissures in steel.

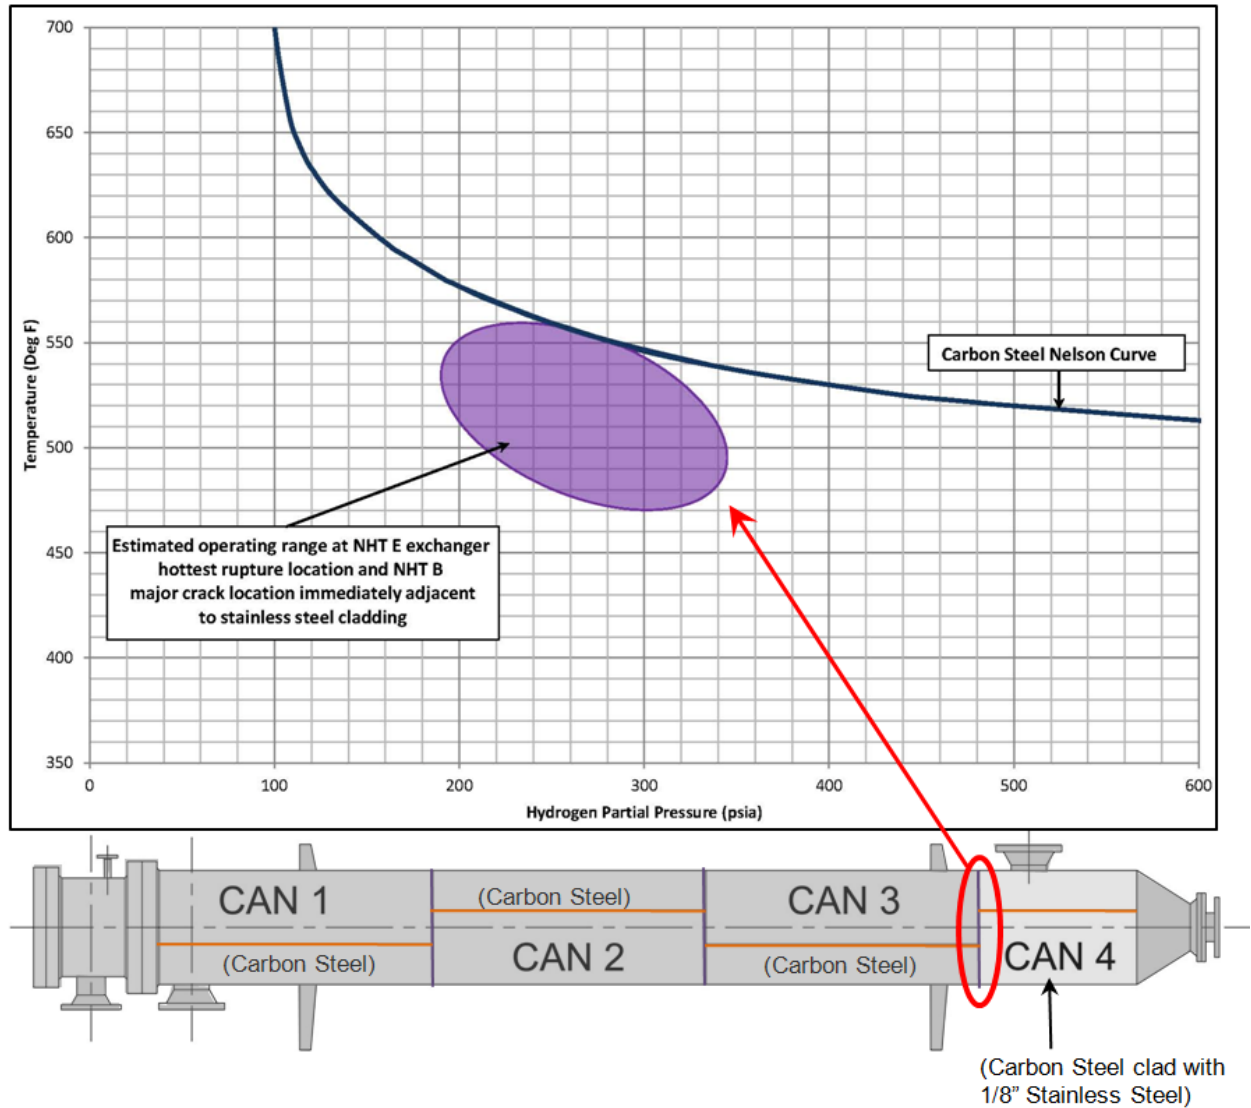
Figure 26. Model Results for the Weld Downstream of Can 4. The circumferential weld immediately downstream of the stainless-steel-clad portion of the carbon steel B and E heat exchangers was estimated to operate just below the carbon steel Nelson curve. Extensive HTHA was found in this region, the hottest rupture location of the E heat exchanger and the major crack location of the B heat exchanger.

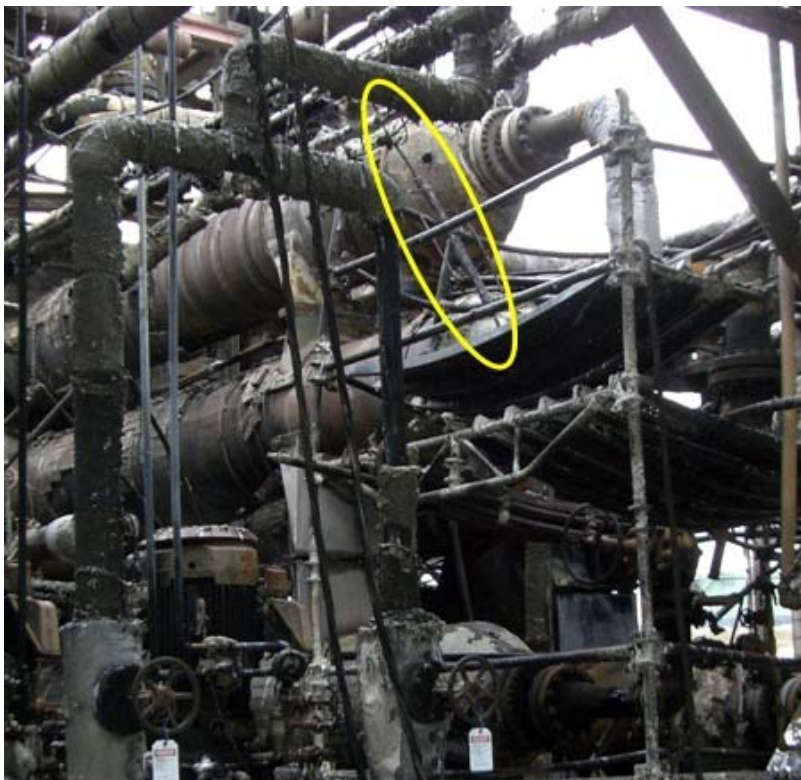
Figure 29. Post-Incident Steam Lance. This photograph shows a steam lance that was likely used during the startup.

exchanger leaks. However, this was the last startup before the April 2010 incident, and a single successful startup without leaks is not evidence of long-term success.¹⁰⁷ One of the four steam lances likely used for leak mitigation on the night of the April 2010 incident is shown in Figure 29.

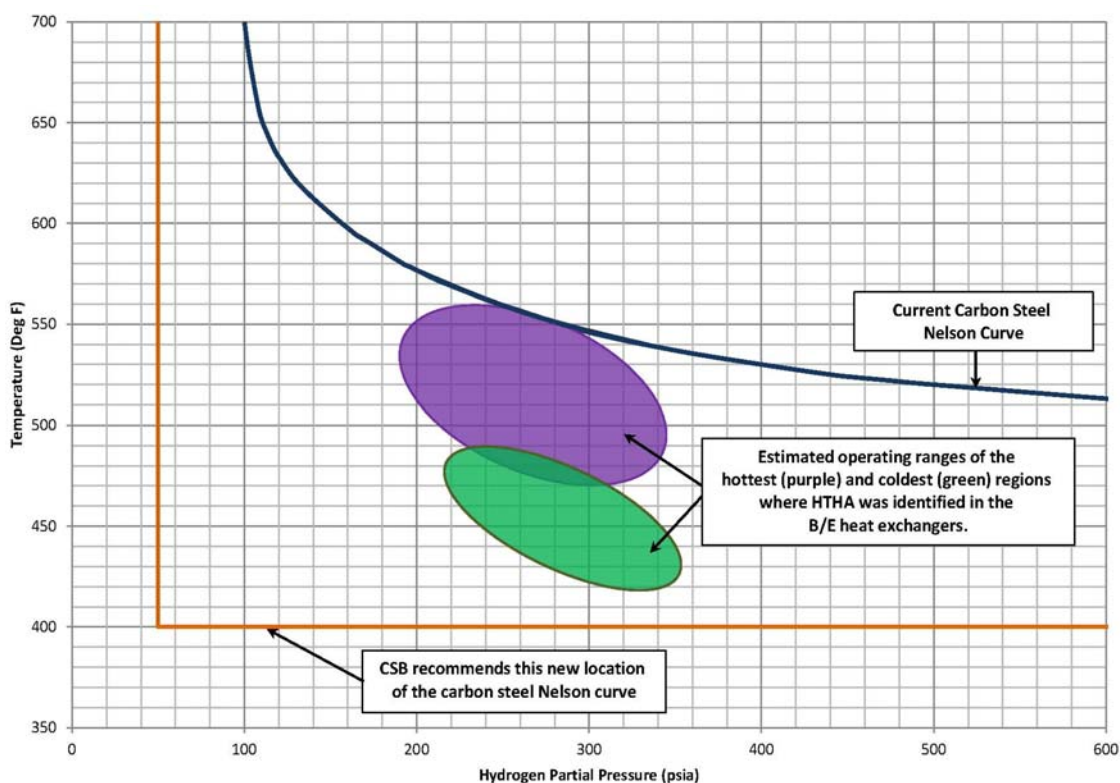
Figure 33. CSB Modeling Results of HTHA and the Nelson Curve at the Tesoro Anacortes Refinery. CSB modeling estimates suggest that HTHA occurred in the B and E heat exchangers below the carbon steel Nelson curve. The CSB recommends that the carbon steel Nelson curve be relocated as shown to prevent HTHA in carbon steel.

Furthermore, CSB modeling of the Tesoro Anacortes refinery NHT heat exchangers suggests the E heat exchanger failed from HTHA damage that occurred below the Nelson curve. In support of inherent safety to prevent equipment failures from HTHA, the CSB proposes a new boundary for the carbon steel Nelson curve in Figure 33. This boundary would prohibit carbon steel equipment at process conditions that API has identified as susceptible to HTHA, above 400 °F,¹⁷⁷ and which operates at greater than 50 psia hydrogen partial pressure.

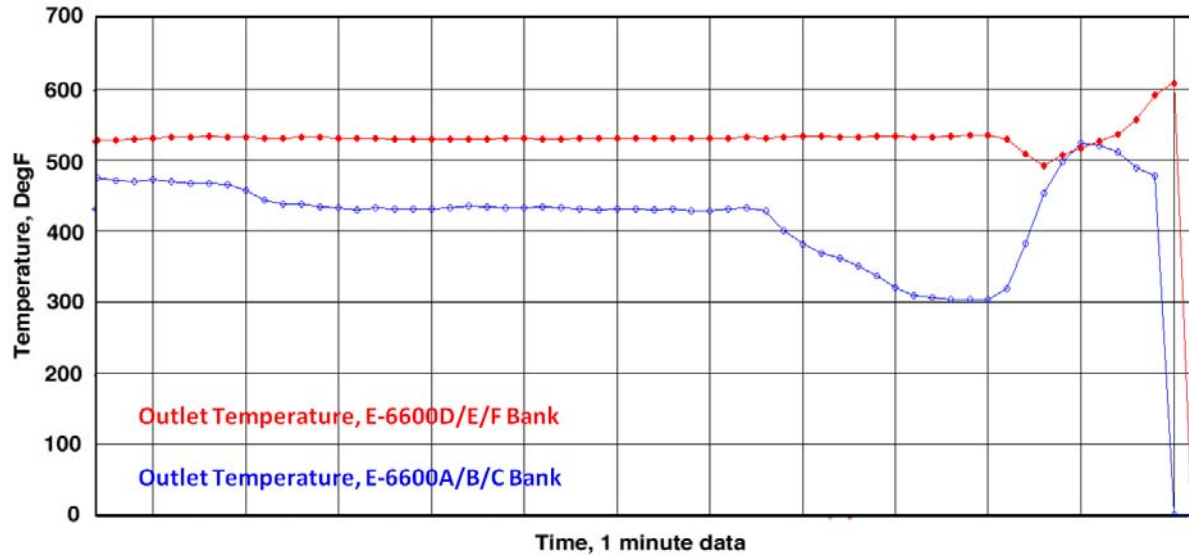
Figure 38. Temperature Data During NHT A/B/C Heat Exchanger Bank Startup on Night of the Incident

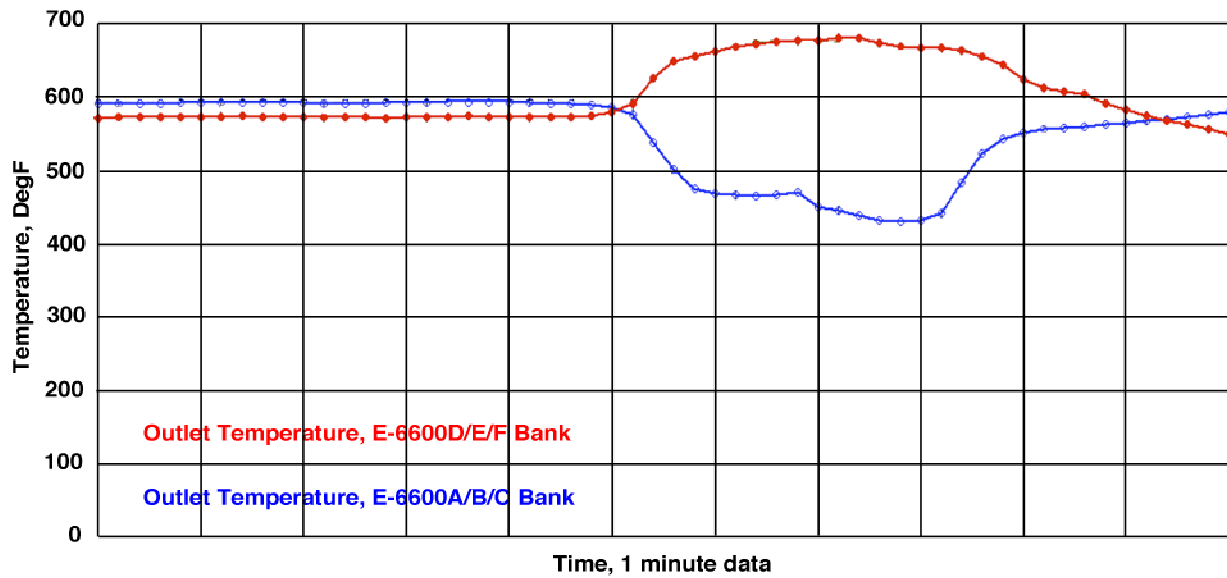
Figure 41. Temperature Data During NHT A/B/C Heat Exchanger Bank Startup on February 3, 2008
