## Investigation Report

Published: September 24, 2021

### SAFETY ISSUES:

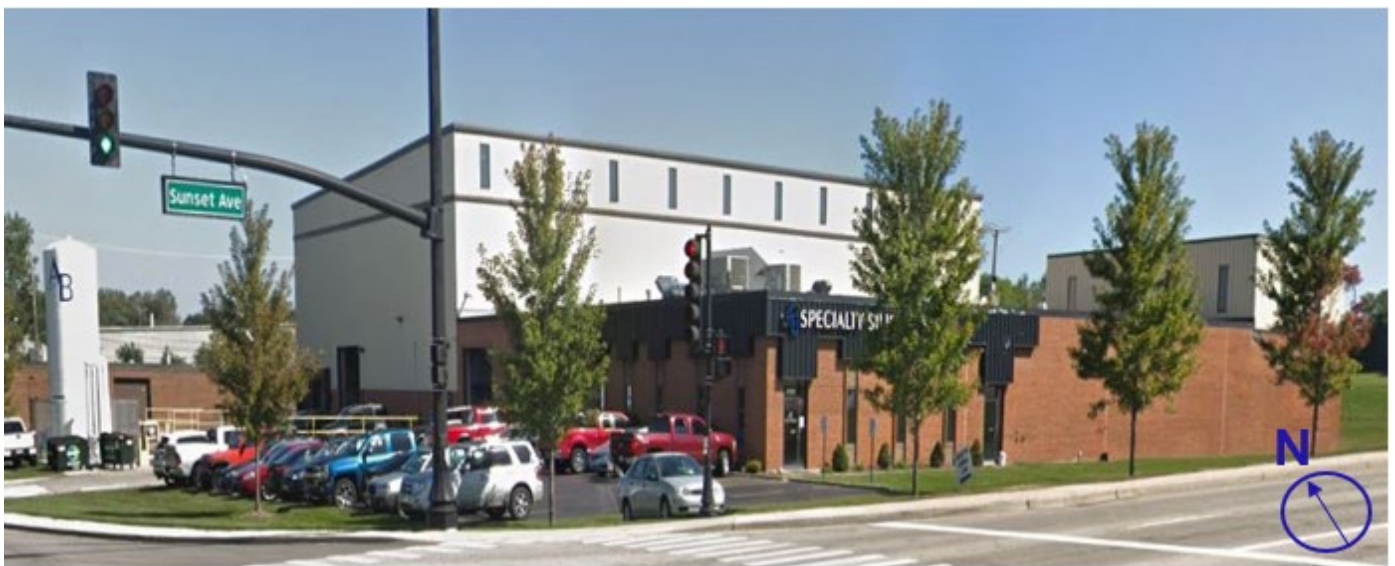
**Figure 1.** AB Specialty production facility in Waukegan, Illinois, before the incident. (Credit: Google Earth)

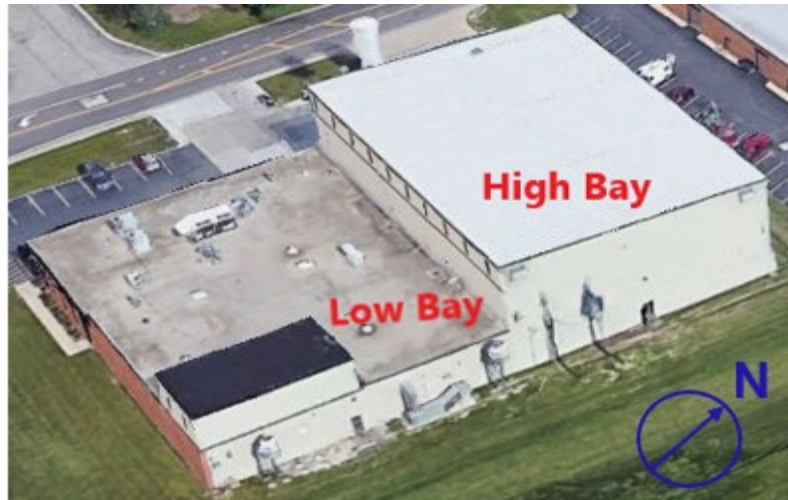
The AB Specialty operation took place inside a production building. The production building was divided into two adjoining areas known as the “High Bay” and the “Low Bay,” named after the physical heights of the structures (**Figure 2**). These bays were subdivided into different production areas, including the “emulsions area,” in which the incident occurred (**Figure 3**), and were equipped with reactors, tanks, storage vessels, and other equipment for the manufacture of various silicone products.

**Figure 2.** AB Specialty production building. (Credit: Google Maps with annotations by CSB)

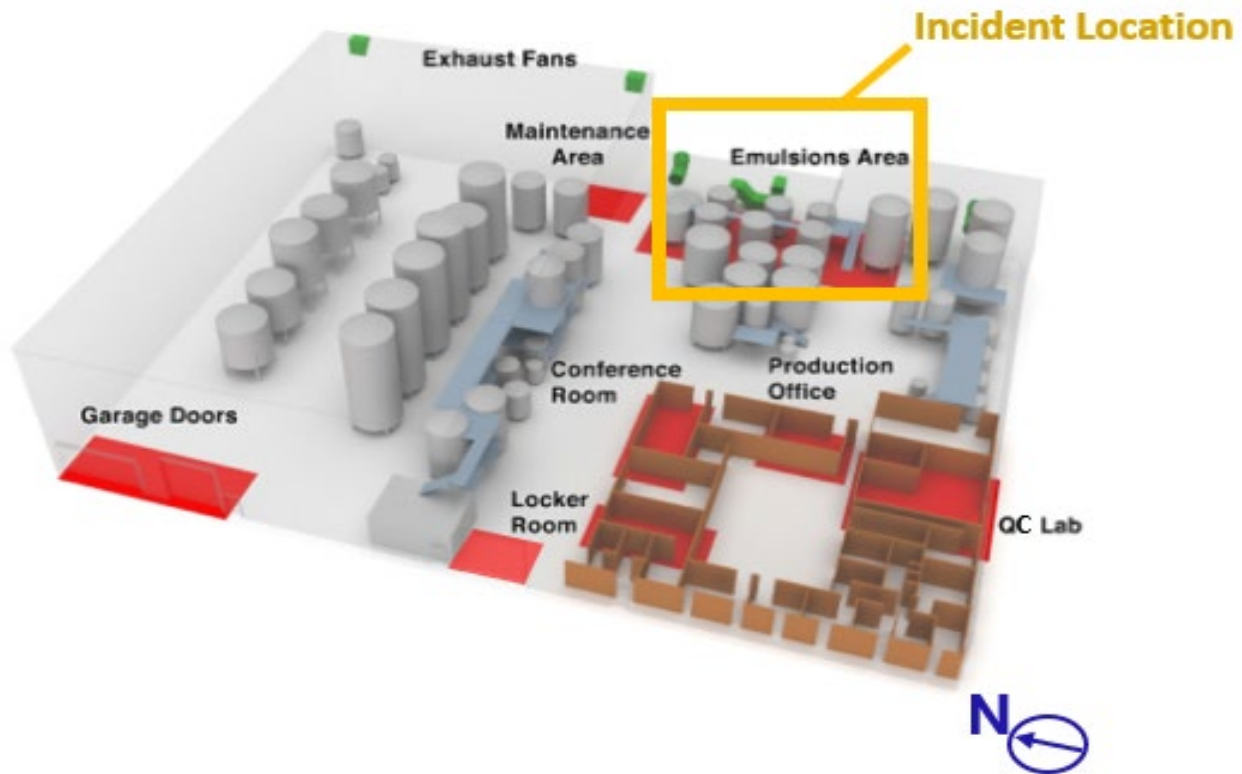
commercially branded as Andisil<sup>®</sup> EM 652 (EM 652),<sup>b</sup> a waterproofing agent, in the Low Bay emulsions area (**Figure 3**). AB Specialty manufactured EM 652 using a batch process. AB Specialty had been producing EM 652 since 2013 as necessary.

**Figure 3.** Production building layout. (Credit: CSB)

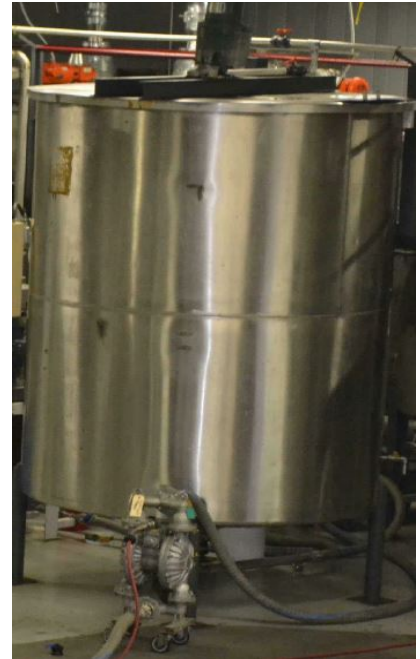
Because AB Specialty manufactured other emulsions and did not make the same emulsion products continuously, AB Specialty used different tanks to perform the EM 652 batch process based on equipment availability. The EM 652 batches were made in tanks that were loosely sealed with a hatch-type lid (**Figure 4**).<sup>c</sup> Workers would open the lids of these tanks during the production process to, among other things, perform visual observations.

The first steps of the batch manufacture of EM 652 specified on the batch ticket included mixing multiple drums of a polymer branded as Andisil® XL 10 (XL 10)<sup>b</sup> with a surfactant called TD 6/12 Blend in a tank (**Figure 4**).<sup>c</sup> These steps were followed by subsequent chemical additions and mixing using additional process equipment and operations as described in **Appendix A**. The batch ticket in use at the time of the incident was not found after the incident.

**Figure 4.** Exemplar AB Specialty batch tank with agitator and lid. (Credit: AB Specialty)

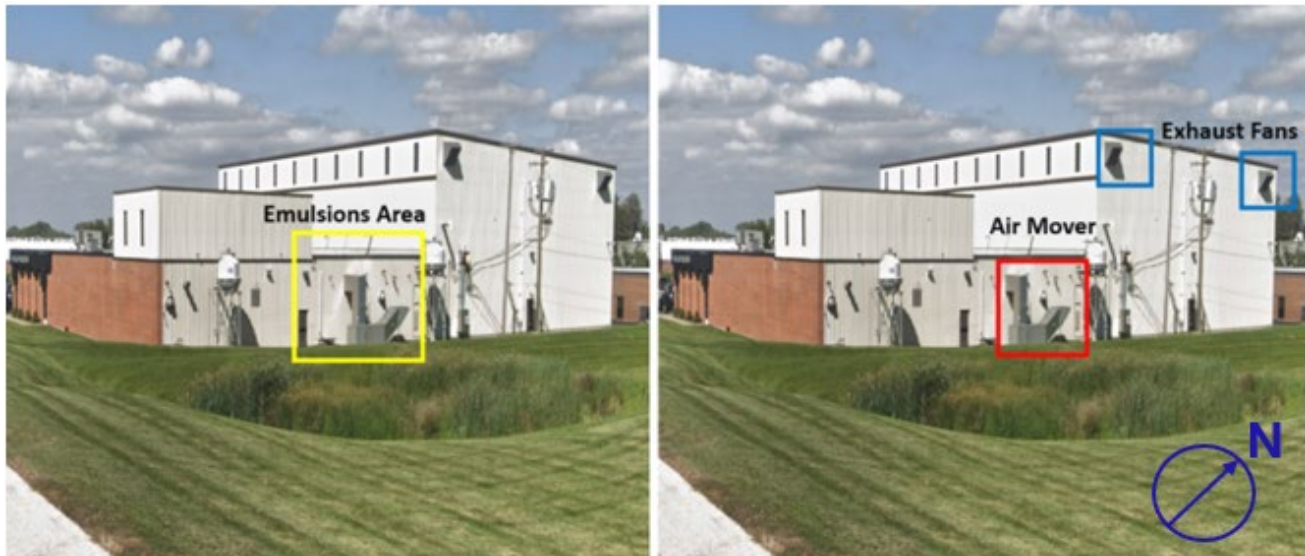
The Low Bay and the High Bay shared a mechanical ventilation system that consisted of air movers and exhaust fans throughout the building. In the production building emulsions area (where the incident occurred), there was one main air mover of 12,000 cubic feet per minute (CFM), as well as one smaller air mover, of 2,000 CFM, on the Low Bay roof. The main air mover provided approximately 86 percent of the total makeup air flow into the production building and could be operated manually. The Low Bay area had four 1,500 CFM roof exhaust fans,

two 1,500 CFM wall exhaust fans, and one 5,000 CFM roof exhaust fan that ran continuously. In addition, on the High Bay end, there were two exhaust fans with a total capacity of about 44,000 CFM. These exhaust fans did not run continuously and had to be manually activated by a switch located in the maintenance area. **Figure 6** shows the location of the emulsions area (yellow box), the main air mover (red box), and exhaust fans (blue boxes) visible on the side of the production building.

**Figure 6.** Location of the emulsions area and the ventilation system components. (Credit: Google Maps with annotations by CSB)

Shift Supervisor 1 directed workers to take action to ventilate the hazy vapor from the building. He asked Operator 2 to open a garage door near the locker room. Shift Supervisor 1 also told Operator 3 to go to the maintenance area and turn on the switch for the fans. This switch would turn on the exhaust fans located in the High Bay (**Figure 3**), which did not run continuously. Before Operator 2 could fully open the garage door and before Operator 3 turned on the fan switch, at about 9:35 p.m., the hydrogen gas ignited, causing a massive explosion and fire.

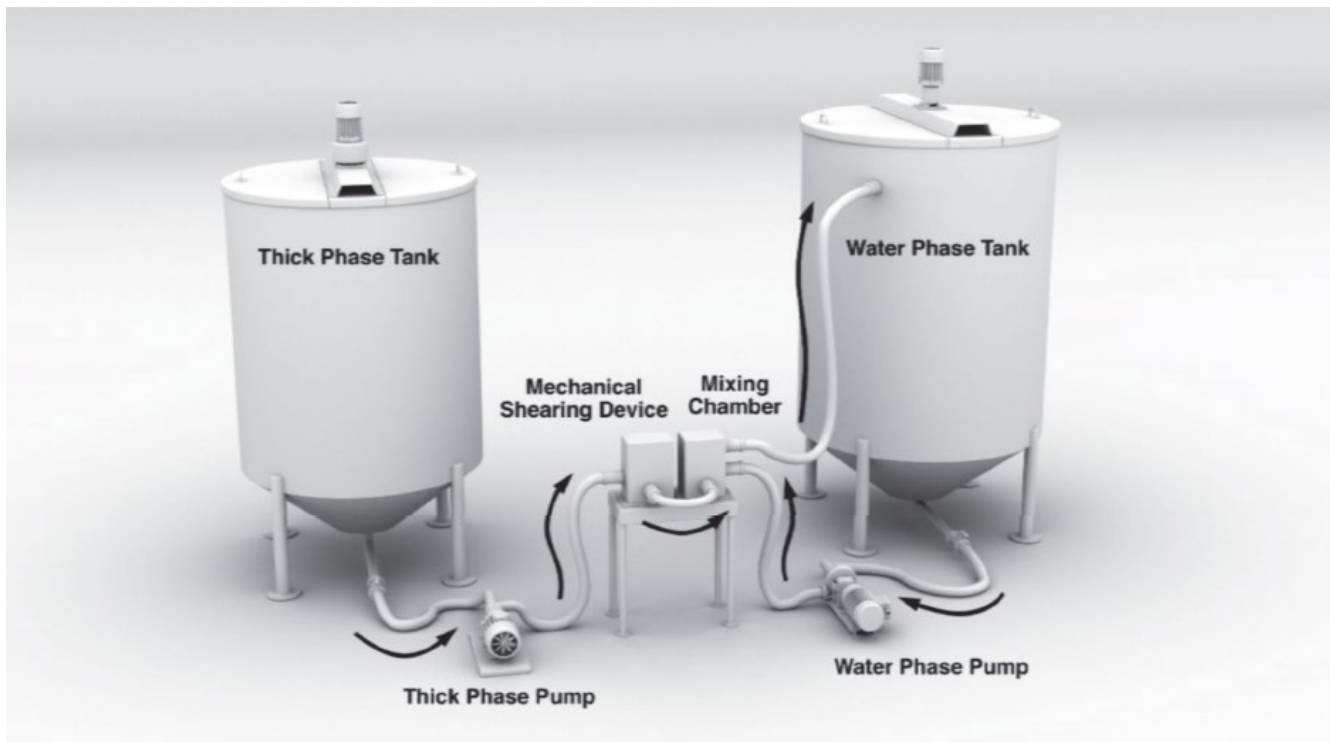
The first raw ingredient added into the Thick Phase Tank was XL 10. After adding multiple drums of XL 10, operators started the agitators. Subsequently, more ingredients were added and mixed into the Thick Phase Tank. Operators would then have to visually observe the materials in the tank to determine whether the process was ready to continue to the next step. While the Thick Phase Tank ran, water was added to the Water Phase Tank. When the process was completed in the Thick Phase Tank, the product would turn from a liquid to a stiff gel. Meanwhile, the water in the Water Phase Tank was circulating through a mixing chamber.

The stiff gel would be pumped from the Thick Phase Tank to a mechanical shearing device. This material was processed through the mechanical shearing device and into the mixing chamber with water from the Water Phase Tank, creating the right consistency in the product, which is like that of milk. The material from the mixing chamber was then fed into the Water Phase Tank. When the product was in the water phase, AB Specialty employees conducted several tests to ensure product quality. These tests were conducted by a QA chemist. Depending on the results of these analytical tests, AB Specialty employees might adjust the pH to bring the product into specification. Once the product is determined to be within specification, the operators are given approval to package. After the final product is packaged, an operator or supervisor will verify the completeness of the batch ticket documentation before it is turned over for administrative processing.

**Figure A-1.** Process schematic of the EM 652 batch process equipment. (Credit: CSB)

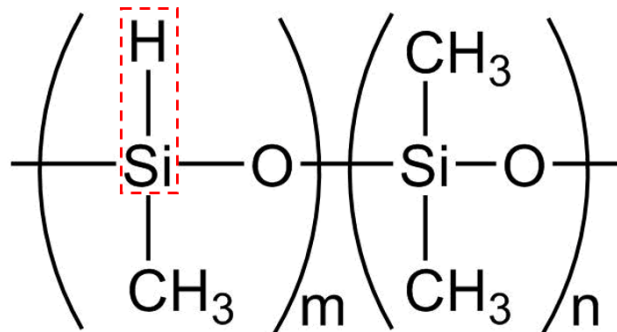
XL 10 is a methylhydrogensiloxane dimethylsiloxane copolymer. The structure of this molecule, which has repeating methylhydrogensiloxane and dimethylsiloxane units, is shown in **Figure B-1**, with the silicon hydride (SiH) bond highlighted. The SiH bond in the copolymer has an “extreme chemical reactivity” with various chemicals, including bases and water [13].

**Figure B-1.** Structure of the methylhydrogensiloxane dimethylsiloxane copolymer (the AB Specialty Silicones product commercially known as XL 10). (Credit: Gelest [37] with modifications by the CSB)

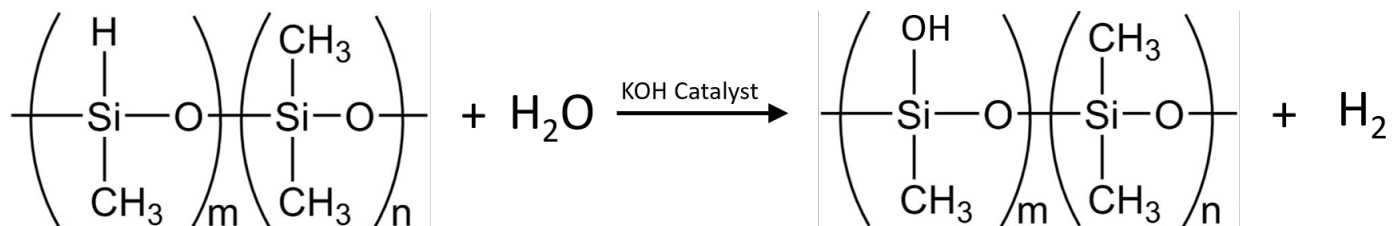
The KOH solution used by AB Specialty contained 10% KOH and 90% water. When 10% KOH, an aqueous base, contacts molecules with SiH bonds, the KOH catalyzes a reaction between the SiH and water, which produces hydrogen [36, p. 6]. This reaction is shown in **Figure B-2**.

**Figure B-2.** Reaction between molecule with SiH bond and water in presence of KOH catalyst. (Credit: CSB, based on image from Gelest [37])

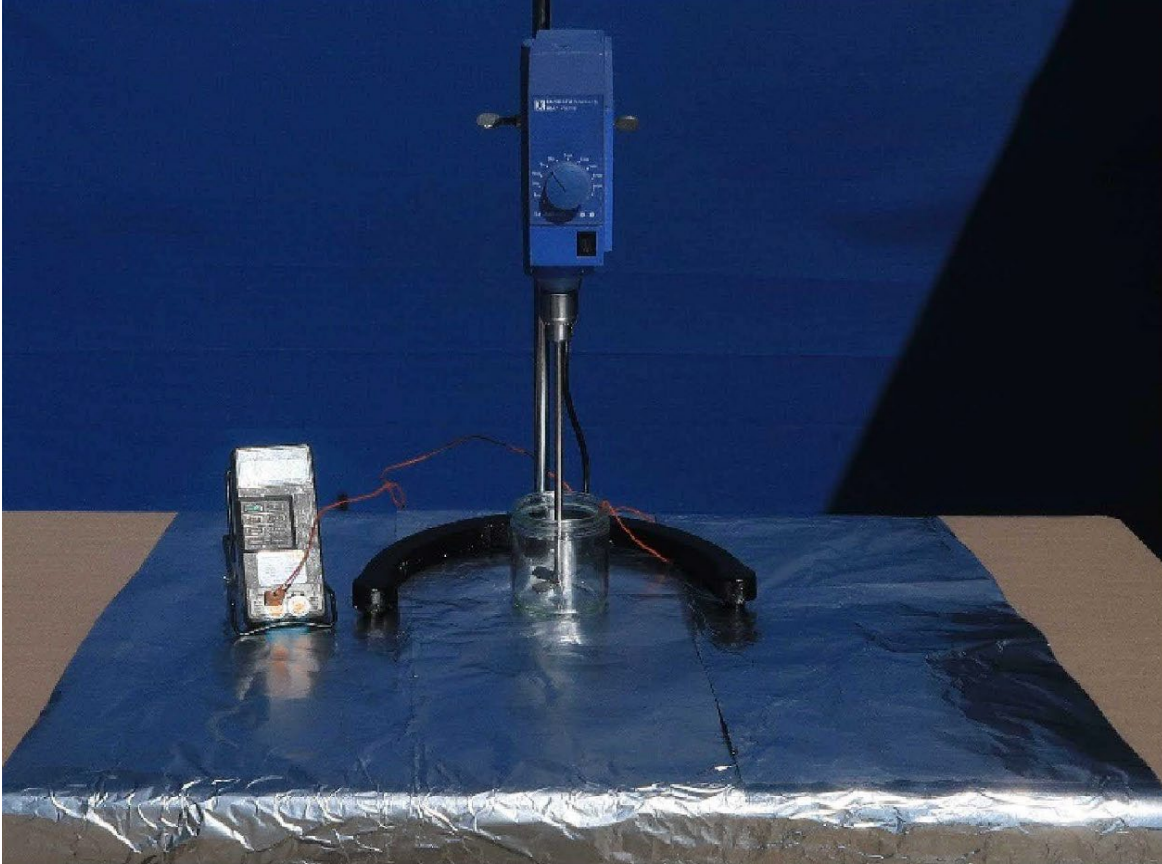
Initial XL 10 reactivity studies (10% KOH, 85% H<sub>3</sub>PO<sub>4</sub>, glacial acetic acid) were labeled according to the reactive material and the volume relative to the XL 10 used (e.g. H<sub>3</sub>PO<sub>4</sub>-0.2 corresponds to 100 ml XL 10 and 20 ml 85% H<sub>3</sub>PO<sub>4</sub>). Later experiments were labeled according to the potentially reactive material and the step during which it was added (e.g. TD-HAc corresponds to glacial acetic acid being added after TD 6/12 Blend was introduced). The "o" designation represents tests conducted in the open system (i.e., o-TD-KOH represents 10% KOH being added after TD 6/12 Blend was added in the open system).

Figure C- 1. Open system experimental setup. (Credit: Crane)

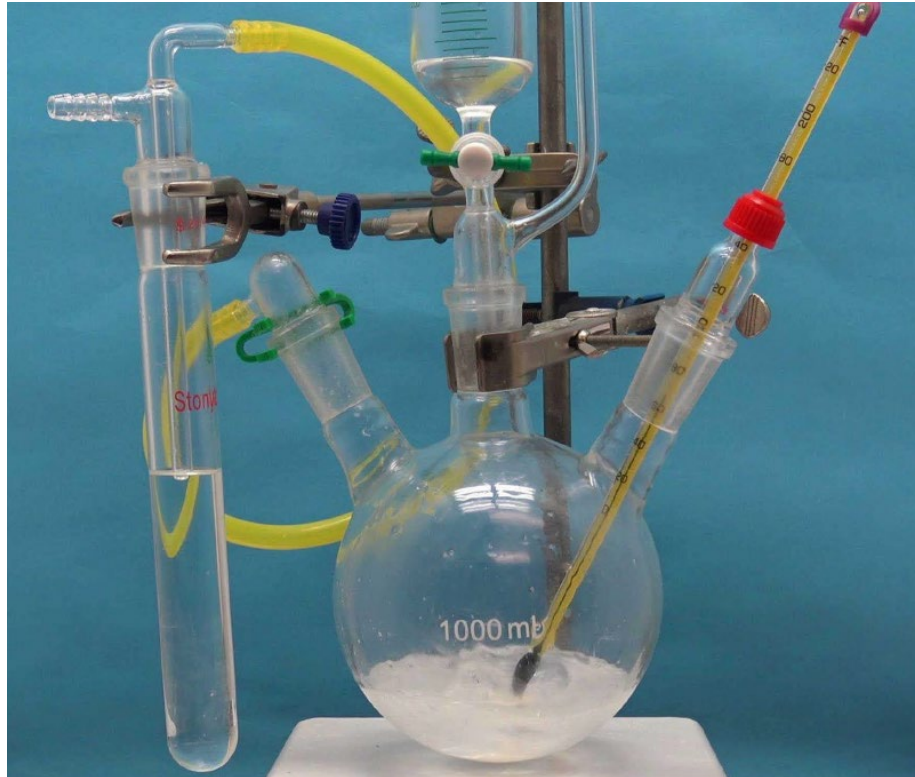
**Figure C- 3.** Closed system experimental setup – without Nitrogen and Flow Meter. (Credit: Crane)

A small-scale experiment was conducted in which the [first] portion of the Andisil® EM 652 batch sheet was followed (i.e. through the addition of Andisil® 137 Silane). The experiment was conducted in a closed system without nitrogen flow as shown in **Figure C- 3**. As a result of the experiment, it was demonstrated that there was no significant temperature increase (other than a few degrees due to some heat from mixing) and there was no gas generation observed.
