HyResponse

Deliverable Number – D2.2

Detailed scenarios of typical accident for selected FCH systems and infrastructures

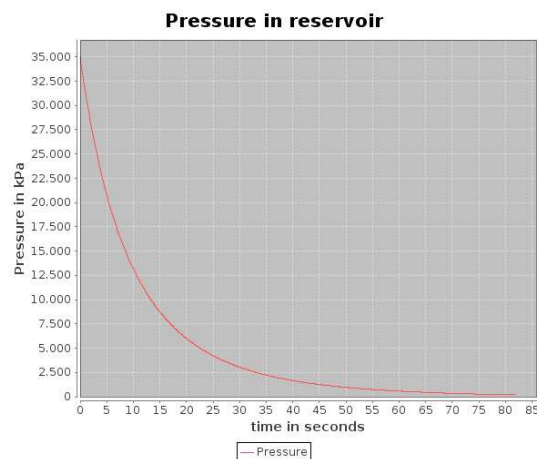
Figure 3: Blowdown process of a 171 L hydrogen tank at initial pressure of 350 bar through a leak of 4.2 mm in diameter

It is important to notice that, during a blowdown process, most of the pressure decays rapidly at the first stage of the process, then, it decays slowly to reach atmospheric pressure as shown on Figure 3 below.

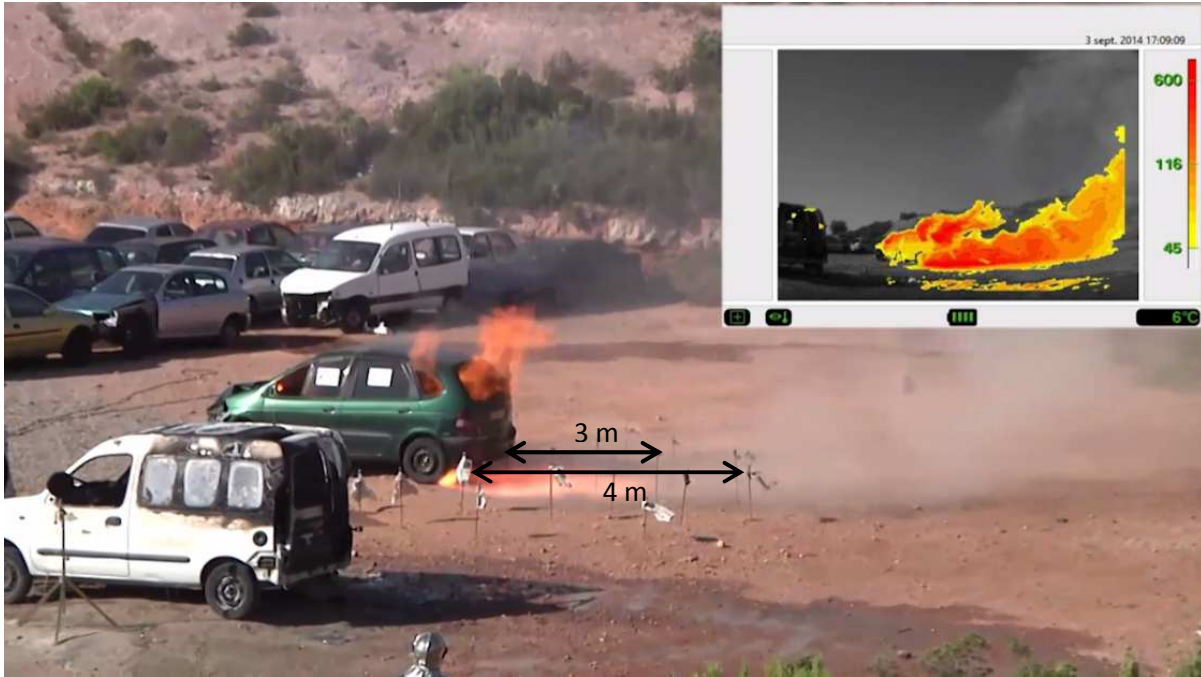
Figure 4: Jet fire exiting from a TPRD mounted on a 700 bar H₂ tank

The Figure 4 shows the visible flame and the thermal flux obtained during the activation of a TPRD mounted on a 700 bar hydrogen tank. It was observed that, despite the ignition of hydrogen, the paper flags located at a distance of 4 m from the back of a car were not burnt after the complete blowdown of hydrogen storage tank.

Nonetheless, it can be seen that a hot cloud released at the initial stage of the blowdown reaches longer distance as indicated by thermal image camera in Figure 4 for 700 bar ignited blowdown. As shown in the Figure 5, this hot cloud is clearly demonstrated for the 350 and 700 bar hydrogen storages in the simulation carried out by the University of Ulster.
